Seen™ IRIS™ 860. The game changer for pedestrian safety

IRIS™ 860 sensor

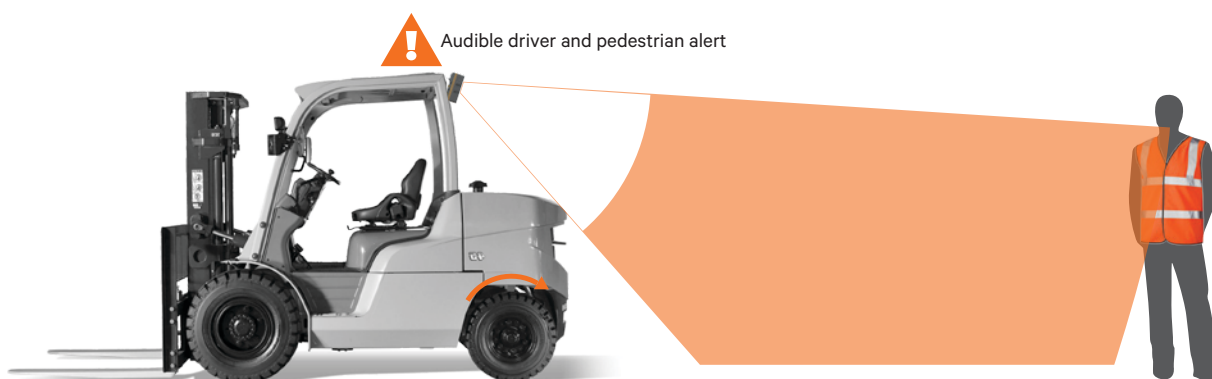
! Audible driver and pedestrian alert

IRIS 860 selectively detects reflective tape on high-vis safety clothing and markers

Pre-set detection range up to 8m
